MODEL 212.0 (except 212.007/074/077/092/095/098) up to 4/14/13
up to model year 2014

B84/3 Backup camera

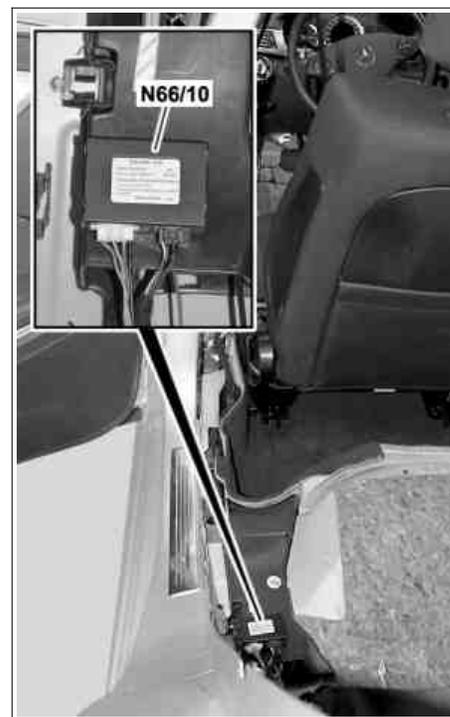
P54.65-4021-03

- 1 Mount reversing camera power supply module (N66/10), as shown, onto left cable duct in the rear and clip in.

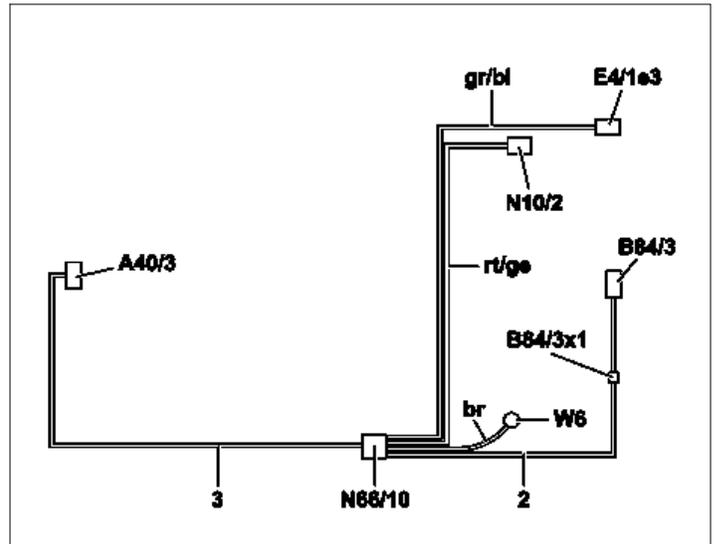
P54.65-4020-11

Connection scheme

- 2 Electrical line (reversing camera)
- 3 Electrical line (COMAND controller unit)
- A40/3 COMAND control unit
- B84/3 Backup camera
- B84/3x1 Backup camera electrical connector
- E4/1e3 Right backup lamp
- N10/2 Rear SAM control unit with fuse and relay module
- N66/10 Backup camera voltage supply module
- W6 Left rear wheel well ground point
- br Brown line
- gr/bl Gray/blue line
- rt/ge Red/yellow line

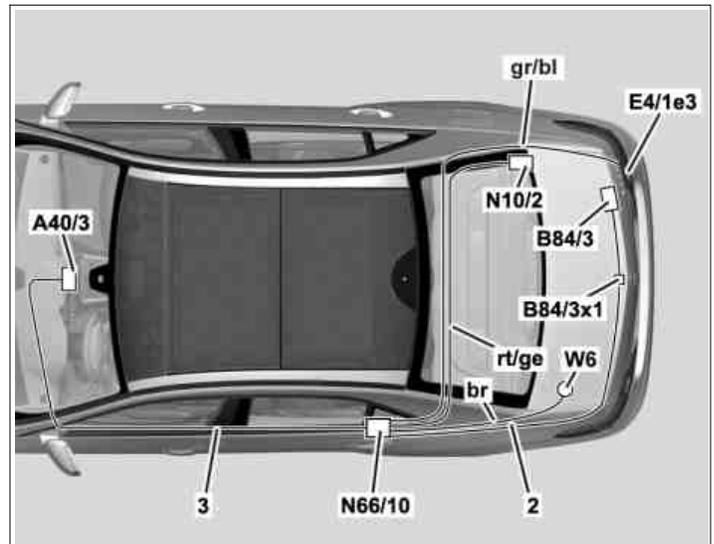
Routing diagram

- 2 Electrical line (reversing camera)
- 3 Electrical line (COMAND controller unit)
- A40/3 COMAND control unit
- B84/3 Backup camera
- B84/3x1 Backup camera electrical connector
- E4/1e3 Right backup lamp
- N10/2 Rear SAM control unit with fuse and relay module
- N66/10 Backup camera voltage supply module
- W6 Left rear wheel well ground point
- br Brown line
- gr/bl Gray/blue line
- rt/ge Red/yellow line

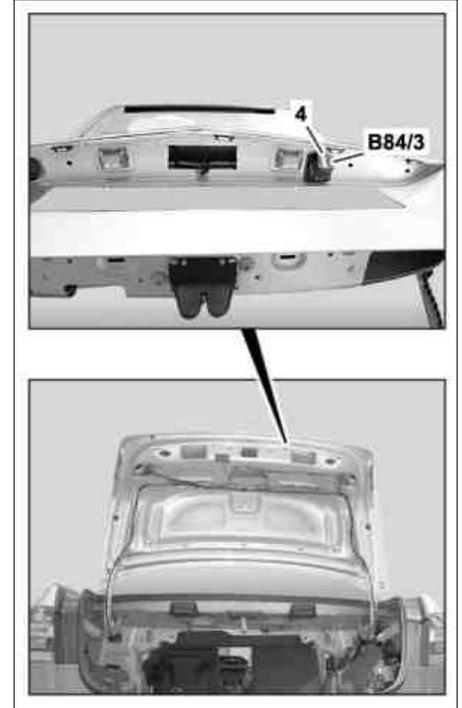
P54.65-4022-03

- 1 Clip reversing camera (B84/3), as shown, into cutout provided in trunk lid and detach protective foil (4).

i Guide the electrical line through into the interior of the trunk lid.

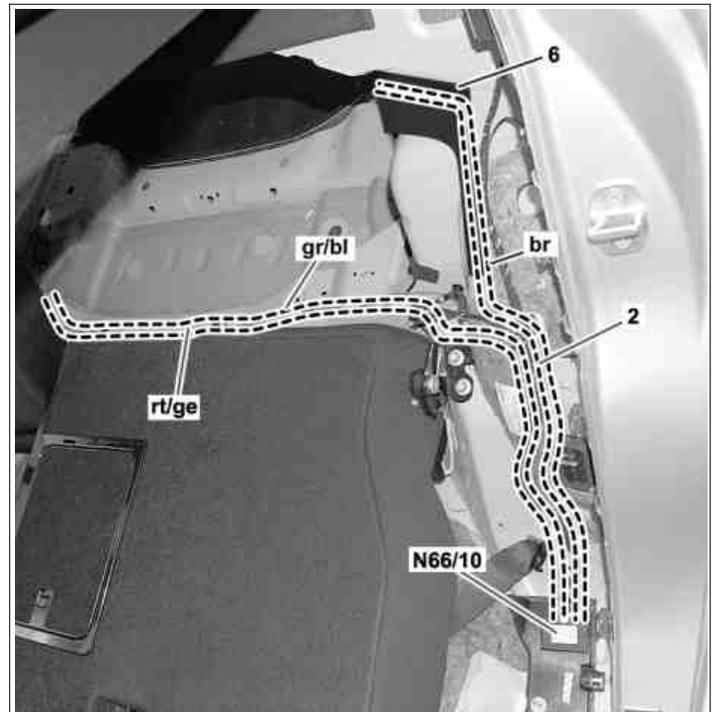
P54.65-4023-12

- 2 Connect black, 4-pin connector and white, 6-pin connector to reversing camera power supply module (N66/10).
- 3 Route electrical line (2) of reversing camera and brown line (BN) through the cable duct (6) to the left side of the trunk.

i If the cable duct (6) is not fitted, this must be retrofitted.

- 4 Route gray/blue line (GY/BU) and red/yellow line (RD/YE) along existing wiring harnesses of reversing camera power supply module (N66/10) to right side of the trunk and fix in place using cable ties.

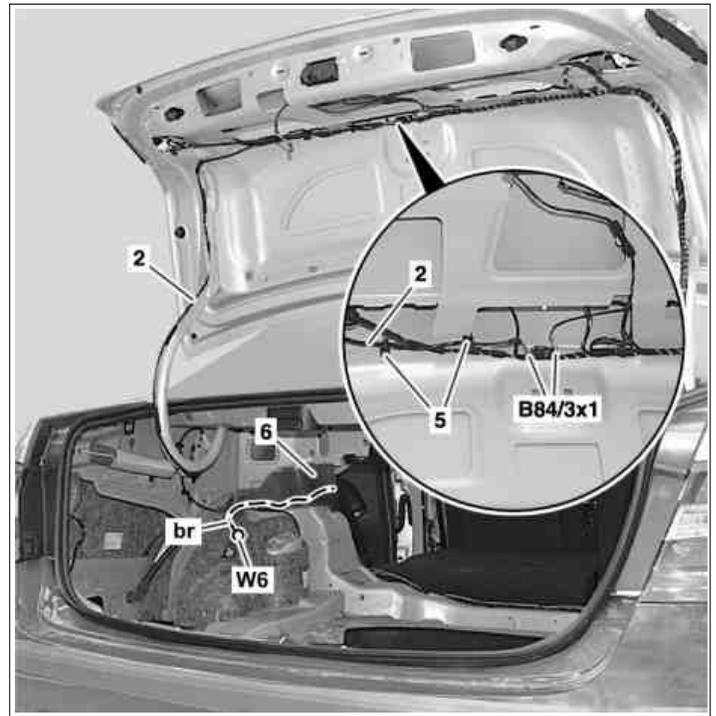
P54.65-4024-12

- 5 Route electrical line (2) from cable duct (6) to reversing camera, clip the clips connected to the electrical line (2) into the corresponding holes and fit clamps (5), as shown, onto the trunk lid.

i Observe wiring in the area of the trunk lid hinge. The electrical line (2) must be routed with adequate clearance.

- 6 Make electrical connection for reversing camera (B84/3x1).

i To do this, connect black 4-pin coupling of electrical line (2) and black 4-pin connector of reversing camera.

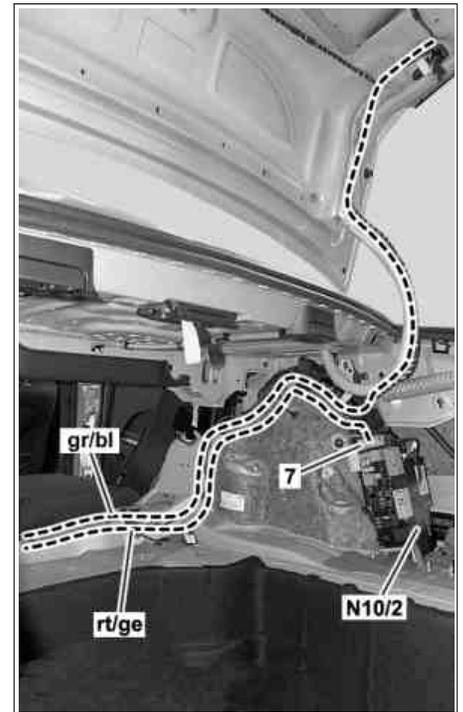
P54.65-4025-03

- 7 Apply preservation agent to clamp contact points (5).

- 8 Connect brown line (BN) to ground point, left rear wheel arch (W6).

- 9 Route gray/blue line (GY/YE) along existing wiring harnesses to right backup lamp and fix in place using cable ties.

i Observe wiring in the area of the trunk lid hinge. The gray/blue (gr/bl) must be routed with sufficient freedom of movement.

- 10 Route red/yellow line (RD/YE) along existing wiring harnesses to green fuse carrier (7) of rear SAM control unit with fuse and relay module (N10/2) and fix in place with cable ties.

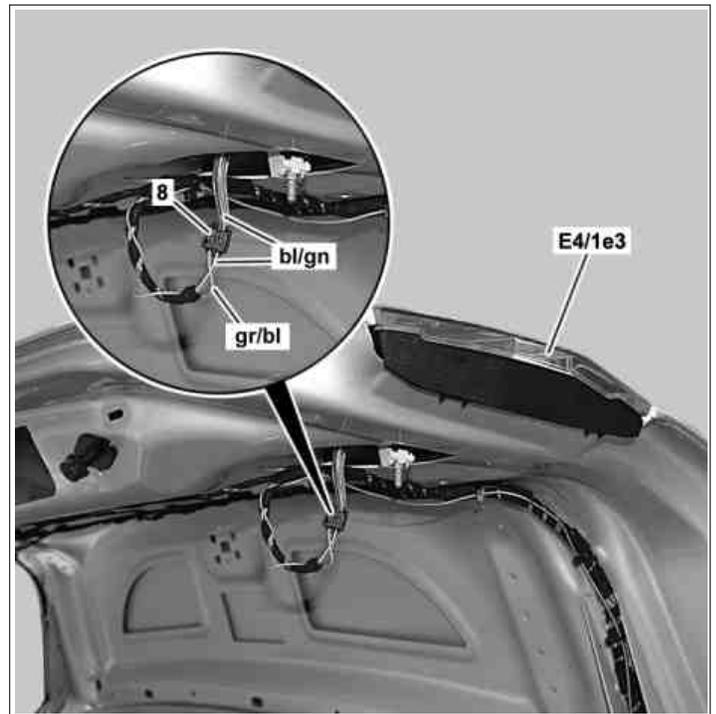
P54.65-4026-12

- 11 Connect gray/blue (GY/BU) of reversing camera wiring harness to the blue/green line (BU/GN) of right backup lamp (E4/1e3) using potential distributor (8) and wrap felt tape around potential distributor (8).

i The potential distributor (8) can be obtained from the wiring harness repair kit

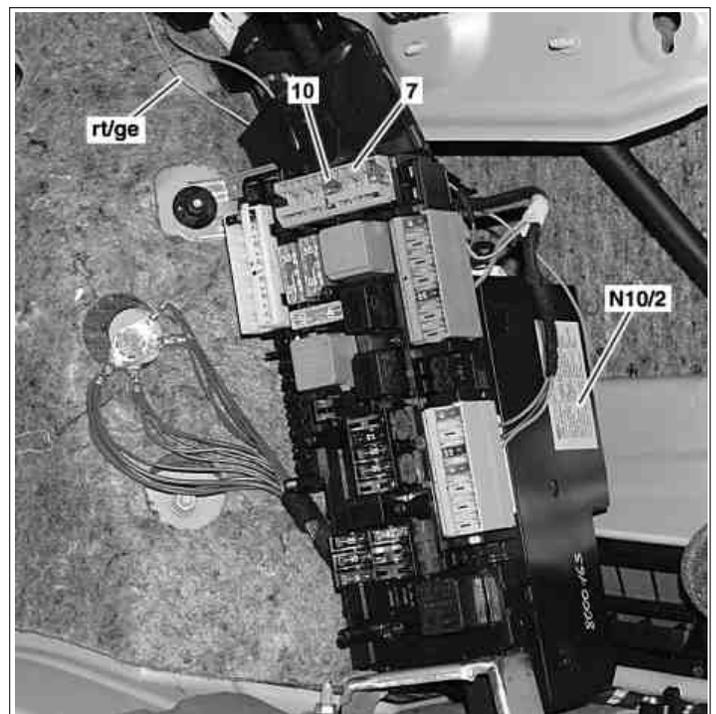
P54.65-4027-12

- 12 Remove green fuse carrier (7) from rear SAM control unit with fuse and relay module (N10/2).

- 13 Install red/yellow line (RD/YE) into contact cavity 4 of green fuse carrier (7).

- 14 Check fuse assignment of green fuse carrier (7).

i If necessary, replace fuse (10) with a fuse rating of 5 A.

- 15 Mount green fuse carrier (7) onto rear SAM control unit with fuse and relay module (N10/2).

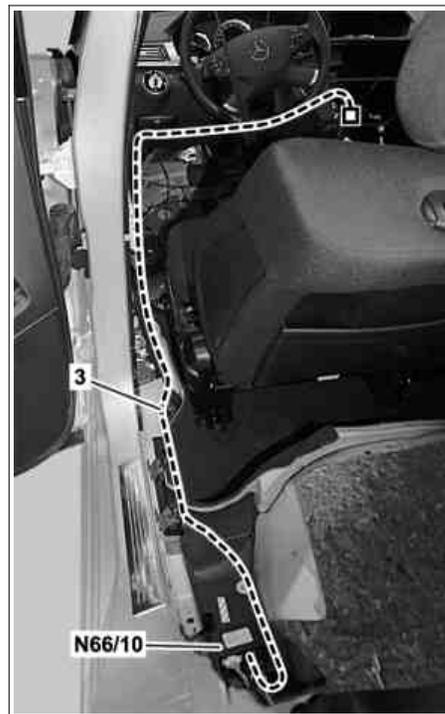
P54.65-4028-03

- 16 Route electrical line (3) from reversing camera power supply module (N66/10) in the existing cable ducts along existing wiring harnesses to the radio recess and fix in place using cable ties.

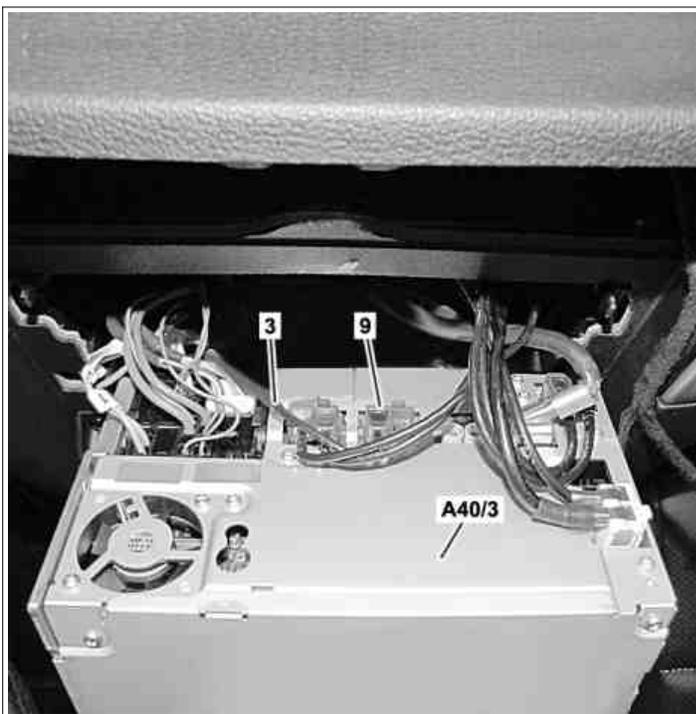
P54.65-4029-12

- 17 For vehicles without CODE 518 (Media Interface) and without CODE 610 (Night View Assist) Install electrical line (3) into the green, 2-pin connector (9) included in the scope of supply, and plug green, 2-pin connector (9) onto green slot of COMAND controller unit (A40/3).
- 18 For vehicles with CODE 518 (Media Interface) or with CODE 610 (Night View Assist) Remove green, 2-pin connector (9) from COMAND controller unit (A40/3), install electrical line (3) into free slot of green, 2-pin connector (9) and plug green, 2-pin connector (9) onto green slot of COMAND controller unit (A40/3).

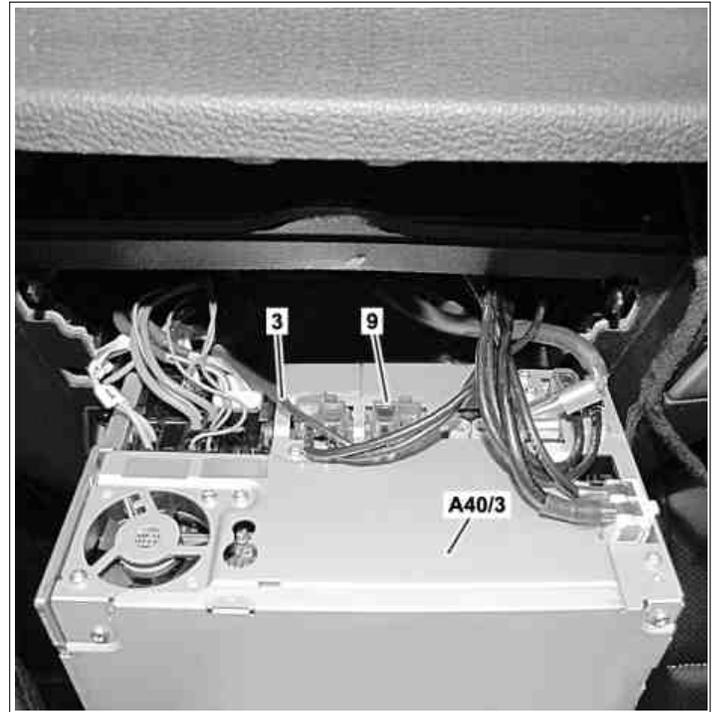
P54.65-4029-12

- 19 For vehicles with CODE 518 (Media Interface) and with CODE 610 (Night View Assist) Detach green, 2-pin connector (9) from COMAND controller unit (A40/3).
- 20 For vehicles with CODE 518 (Media Interface) and with CODE 610 (Night View Assist) Remove media interface coupling from contact cavity "1" of given green 2-pin coupling (9), wrap with felt tape and strap down onto the vehicle wiring harness.
- 21 For vehicles with CODE 518 (Media Interface) and with CODE 610 (Night View Assist) Install electrical line (3) into free slot of existing green, 2-pin connector (9) and plug green, 2-pin connector (9) onto green slot of COMAND controller unit (A40/3).

The media interface video feature is no longer available.
